HVOF APPLIED COATING - Corrosion Resistance

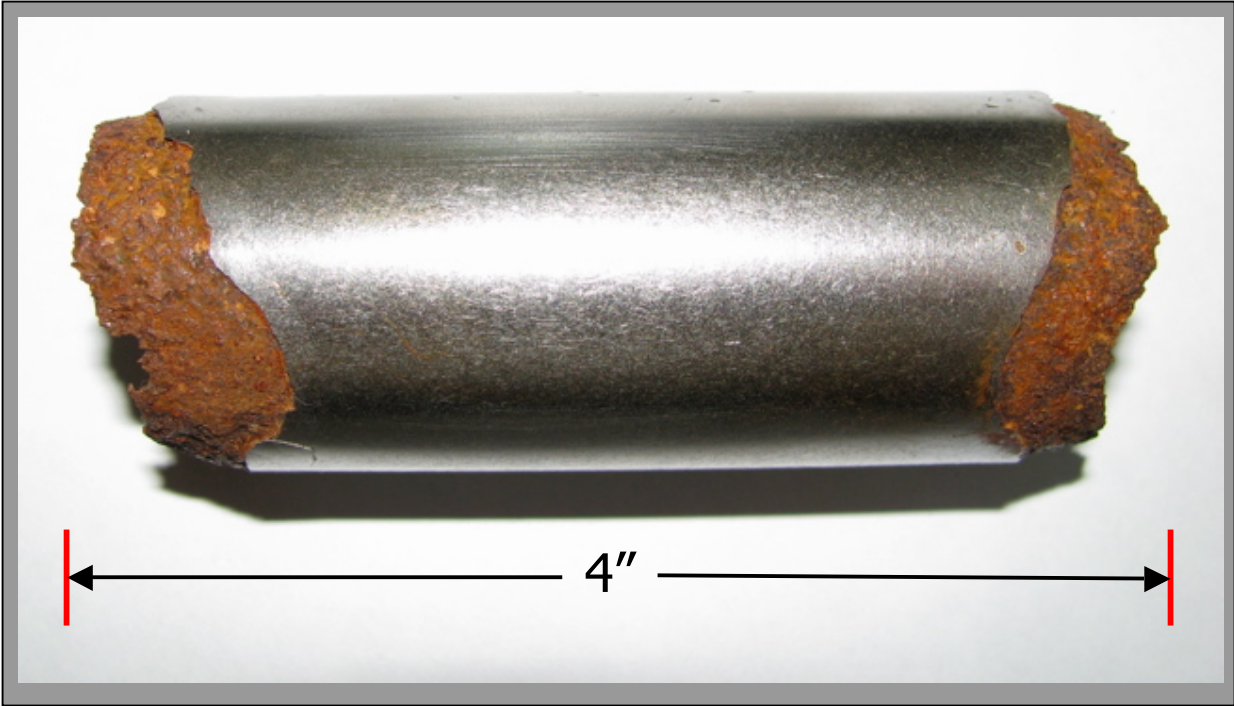
Internal Test - This Sample Piece Was Submerged In The Chesapeake Bay For Over One Year. The Base Material Is Carbon Steel And The Pipe Is Corroding From The Inside Out.
